ACCRETIONS IN CEMENT SILOS : REASONS FOR FORMATIONS AND PREVENTIVE MEASURES

P C Kulkarni, V Y Wani, S A Khadilkar and P Srinivasan

The Associated Cement Companies Ltd, India

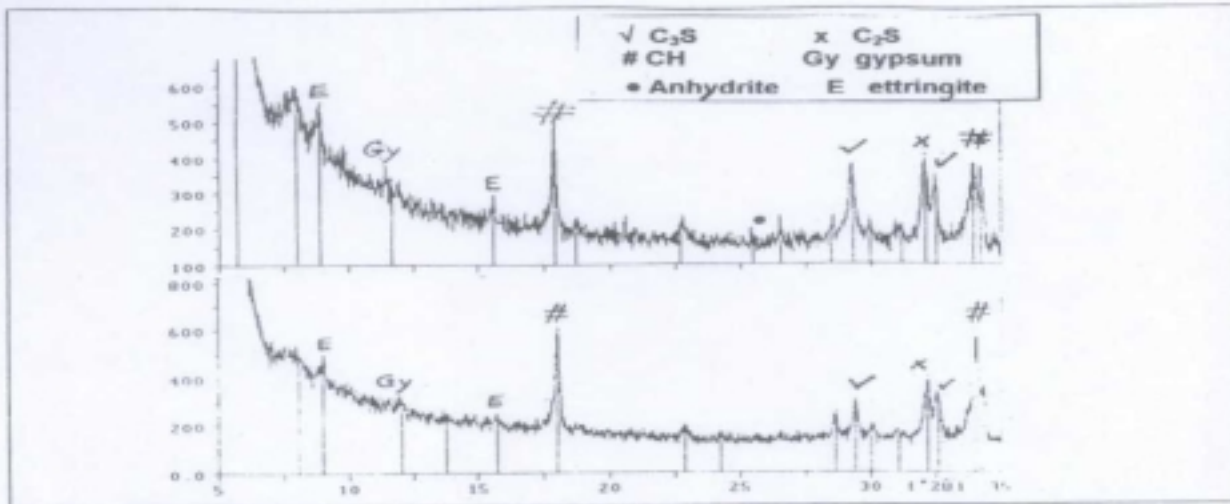
Fig : 4 XRD scan of the harder and the softer portion of the cement lump.

The harder portion was observed to be composed of C_3S , C_2S , Portlandite, anhydrite, Gypsum, Ettringite while the softer outer portion showed C_3S , C_2S , Gypsum, Ettringite and lesser Portlandite, this portion was conspicuous in absence of anhydrite.

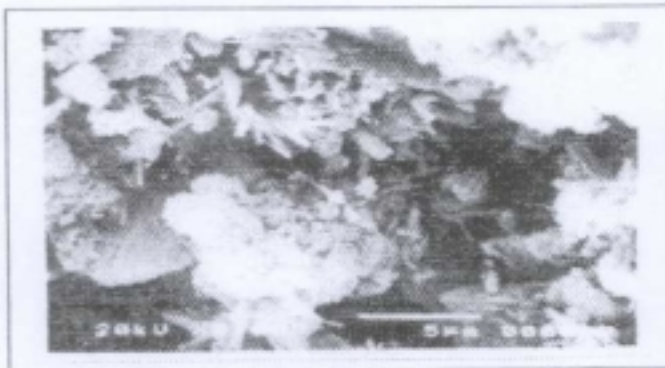
Under electron microscope, the hard part showed fibrous like crystals of anhydrite and gypsum. The quantity of these crystals decreases away from the hard part. Portlandite crystals are also seen in this hard part (Fig:5). However, more crystalline type is seen in the softer region of the samples. Presence of very fine needle like ettringite is also observed throughout the samples (Fig:6).

Fig:5 Anhydrite crystals, fine needles of ettringite in hard part

A temperature gradient in the cooler areas of the silo i.e. near to the wall which causes condensation of water which causes the hydration of the cement grains forming portlandite and developed ettringite crystals resulting into a hard crust. In this portion the water hydrates the dehydrated gypsum produced either during grinding or in the storage silo. Subsequently, more cement grains must have got adhered to this hard crust forming the softer part of lump which shows presence of gypsum and thinner crystals of ettringite.

Subsequently the grinding unit reduced the gypsum added to the slag in grinding of slag and improved ventilation in the storage silo reduced problem of lump formation.

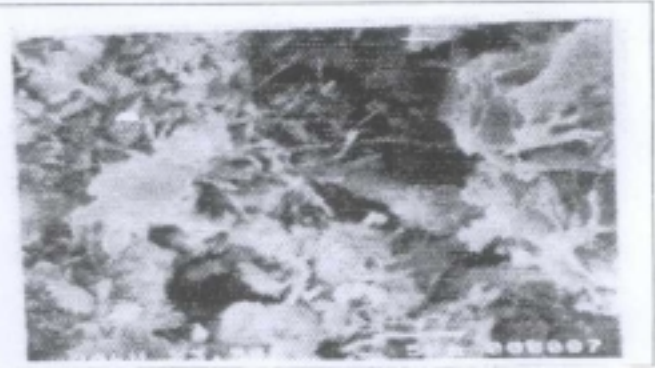
Fig:6 Very fine ettringite needles with prehydrated cement grains in soft part of the lumps

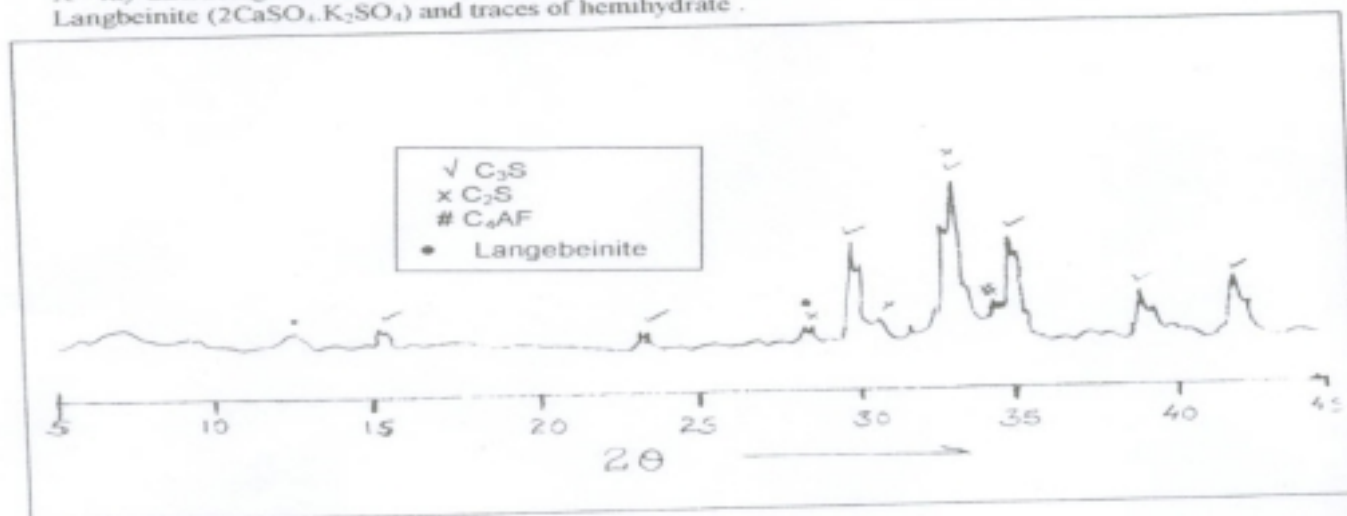
X-ray diffractograms of the sample is shown in, the sample is composed of C₃S, C₂S, C₄AF and Calcium Langebeinite (2CaSO₄·K₂SO₄) and traces of hemihydrate.

Fig : 7 XRD of the soft Lump (Case - II)

The evaluations carried out indicate that in this case the soft agglomeration is due to formation of syngenite traces initiated by the presence of Calcium langbeinite present in the clinker and traces of hemi-hydrate present in the cement. However this could result in harder lumps if there is sufficient water condensation in the cooler areas of silo.

The agglomeration was brought under control by reducing the gypsum levels in combination with control on the cement mill temperature. As a precaution adequate ventilation was provided in cement silo to avoid agglomeration even if the cement is stored for a longer time.
